Geological factors effecting slope instability in the Virginia Coastal Plain: Observations from the 2018 Nottoway Lane Rotational Landslides, King William County

VA Department of Mines, Minerals, and Energy
Division of Geology and Mineral Resources

April 18, 2019

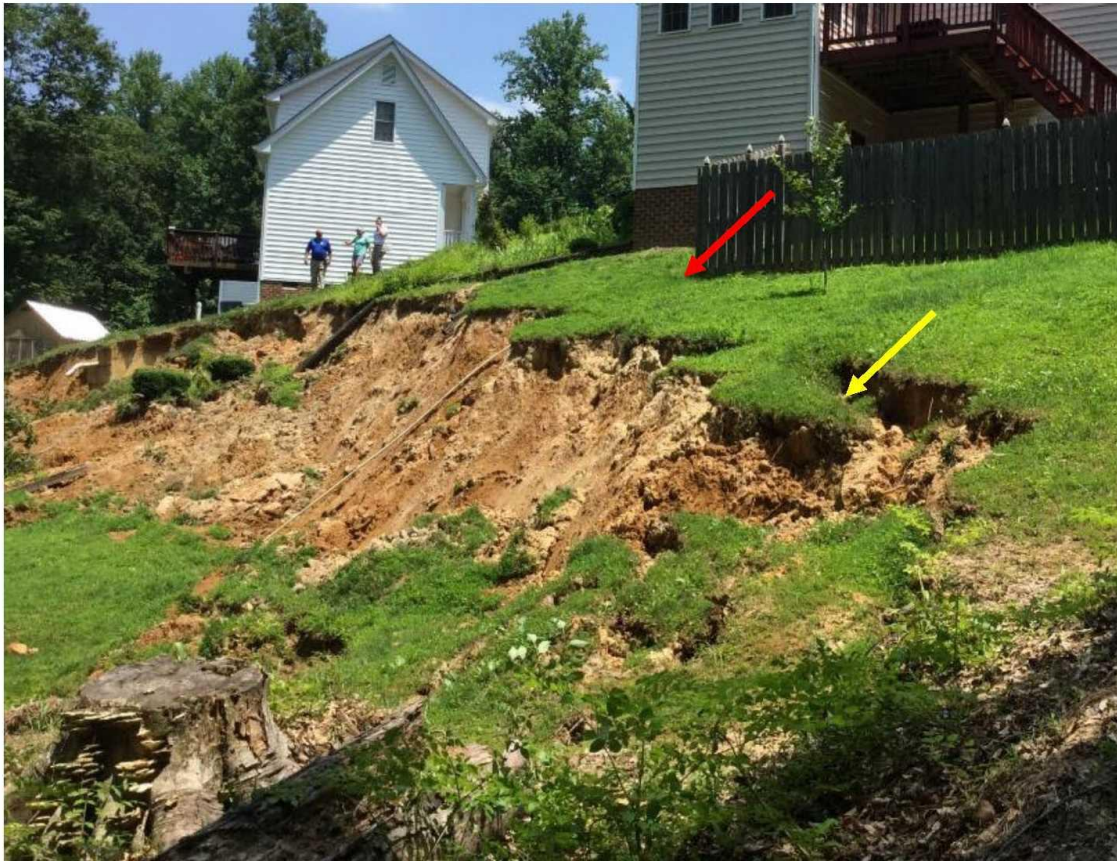
June 19, 2018

- DGMR was first alerted to the landslide on June 19 as a request for assistance from VDEM and the King William Dept of Emergency Management
- First reported as a sinkhole behind two houses at 360 and 362 Nottoway Lane
- Both homes were condemned on June 19

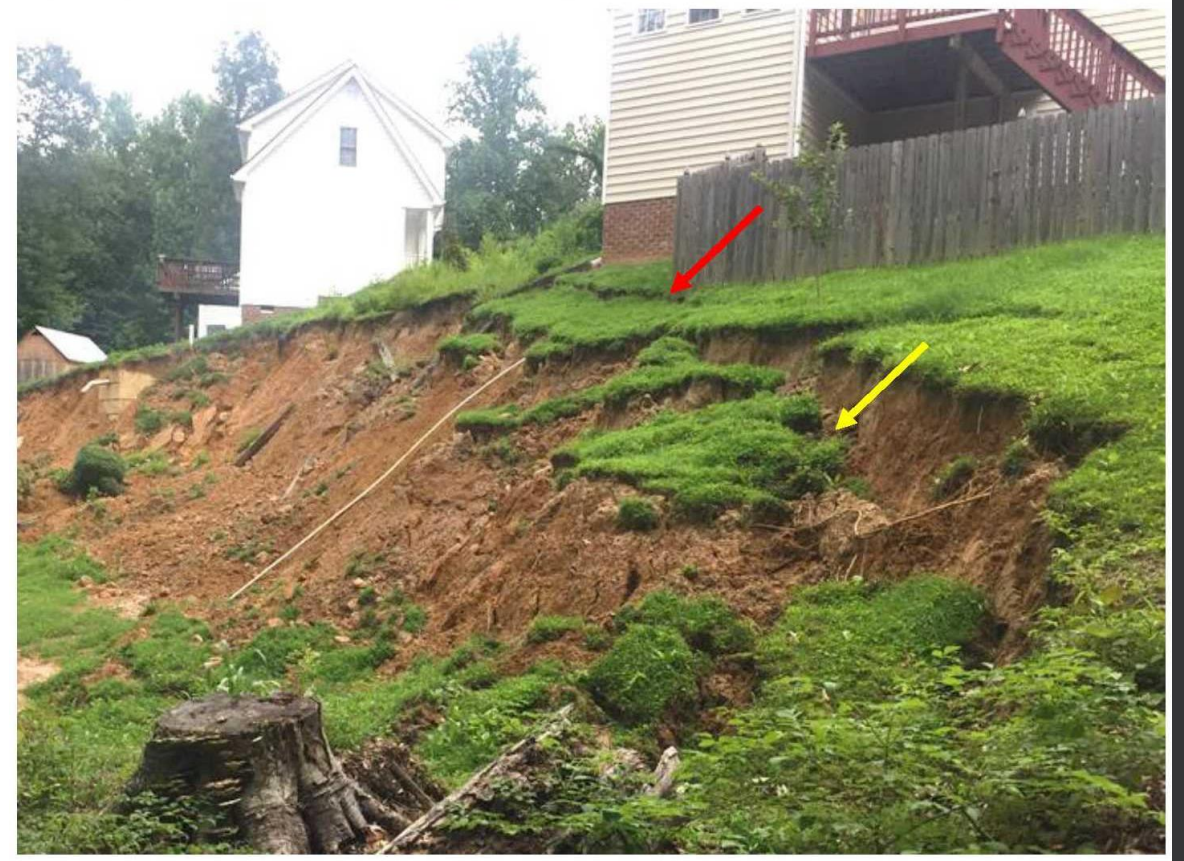
June 25, 2018

- King William EM reported on June 25 that slumping and cracking was continuing uphill towards the houses
- DGMR did a preliminary assessment on June 27 to confirm it was a landslide

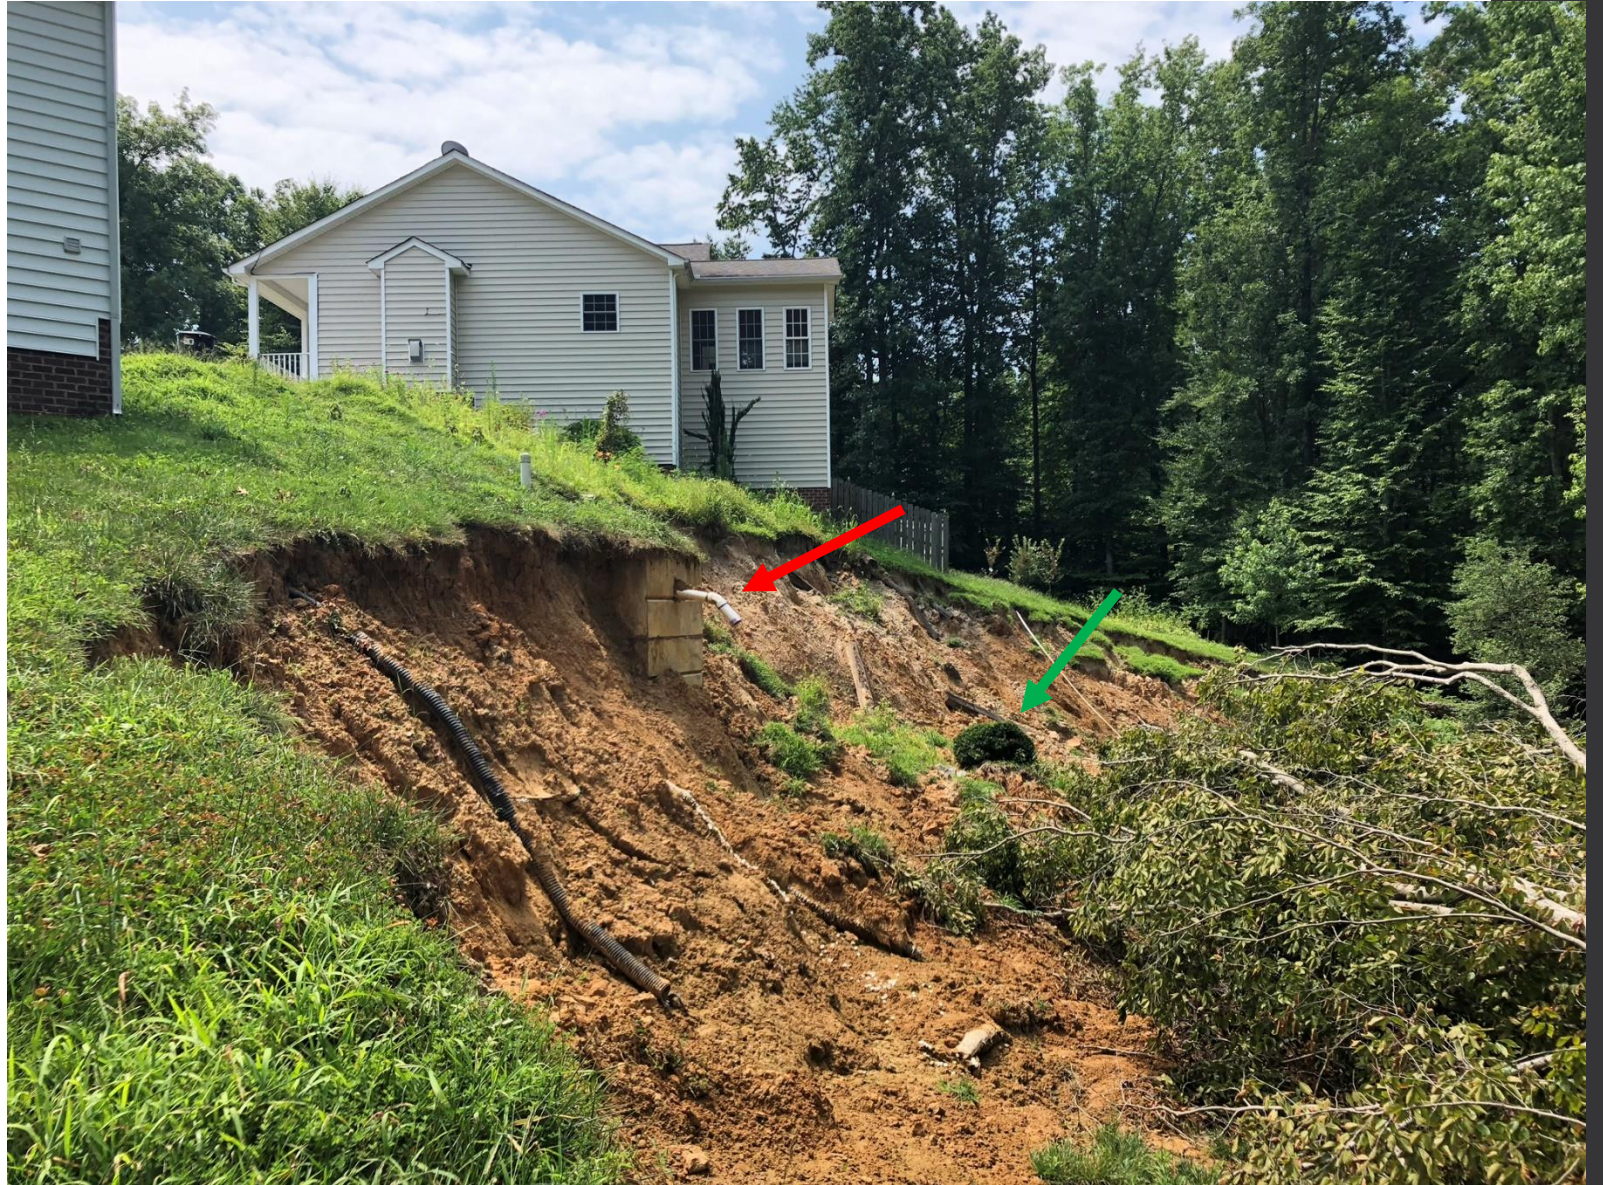
- DGMR revisited site on July 11
- Main headscarp approximately 20 feet high

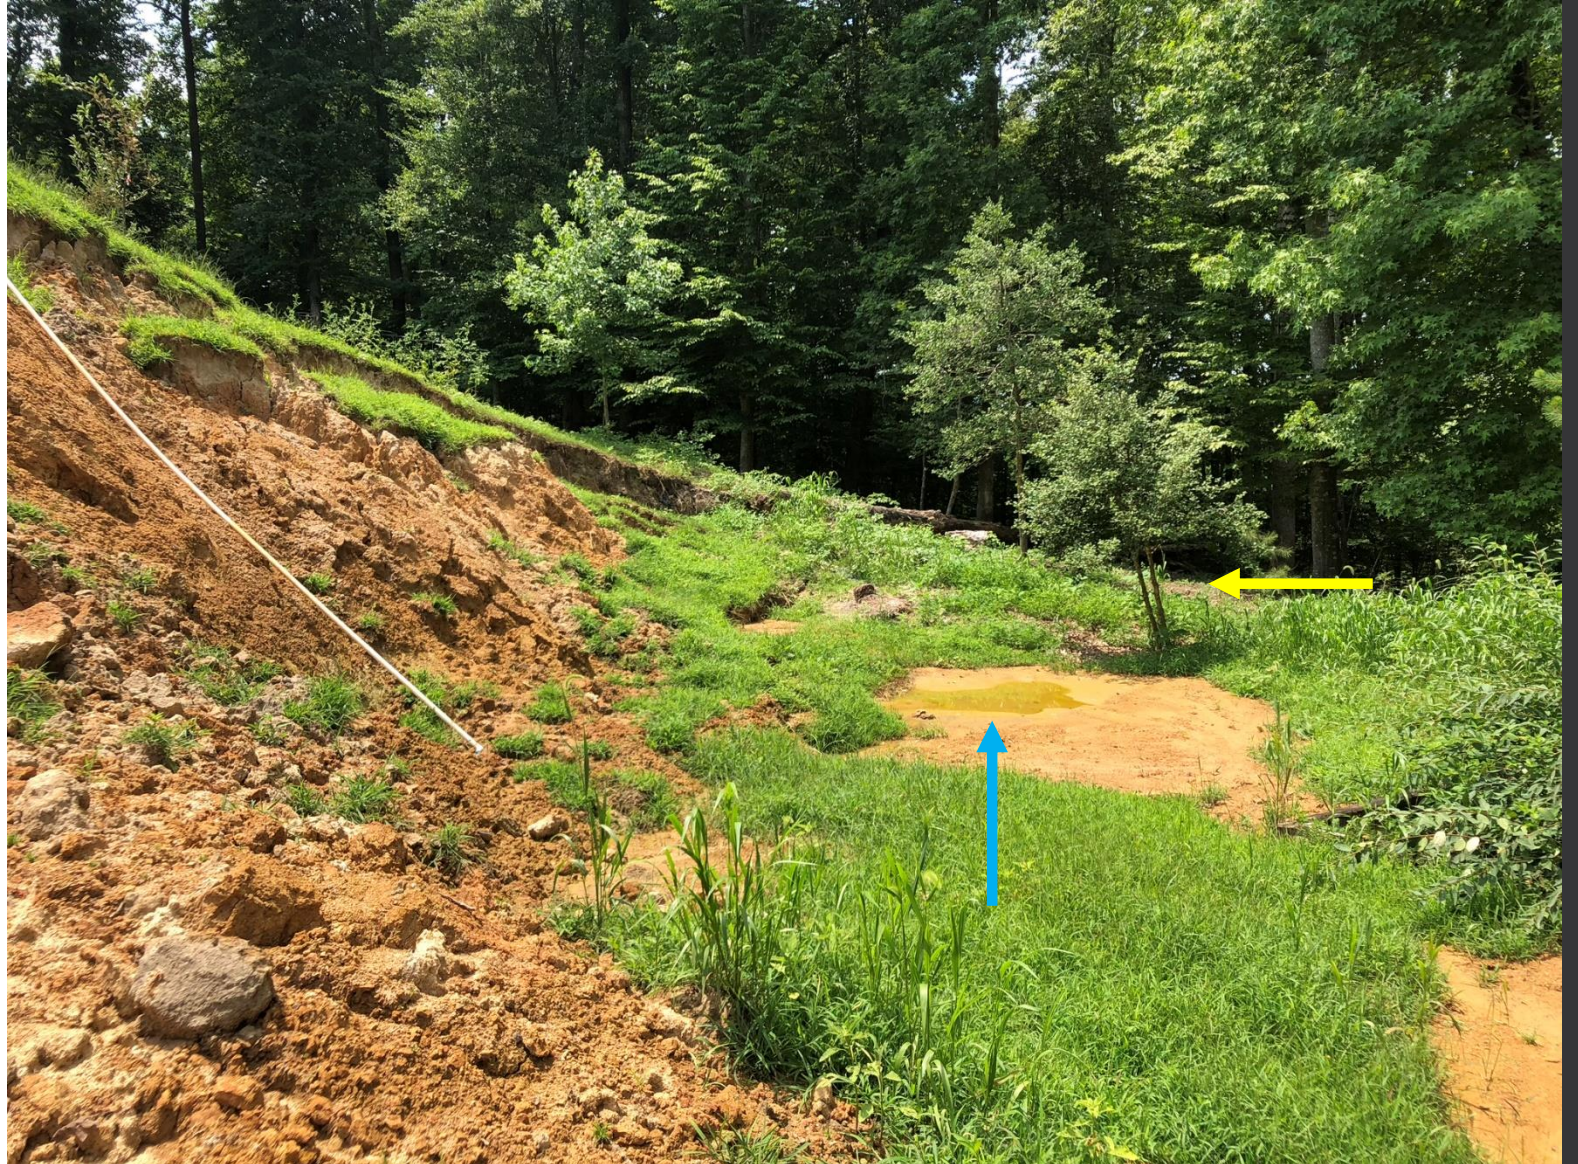
- DGMR revisited site on July 11
- Main headscarp approximately 20 feet high
- Ponding at base of headscarp
- Numerous back rotated trees indicating that there was a rotational component to the landslide movement

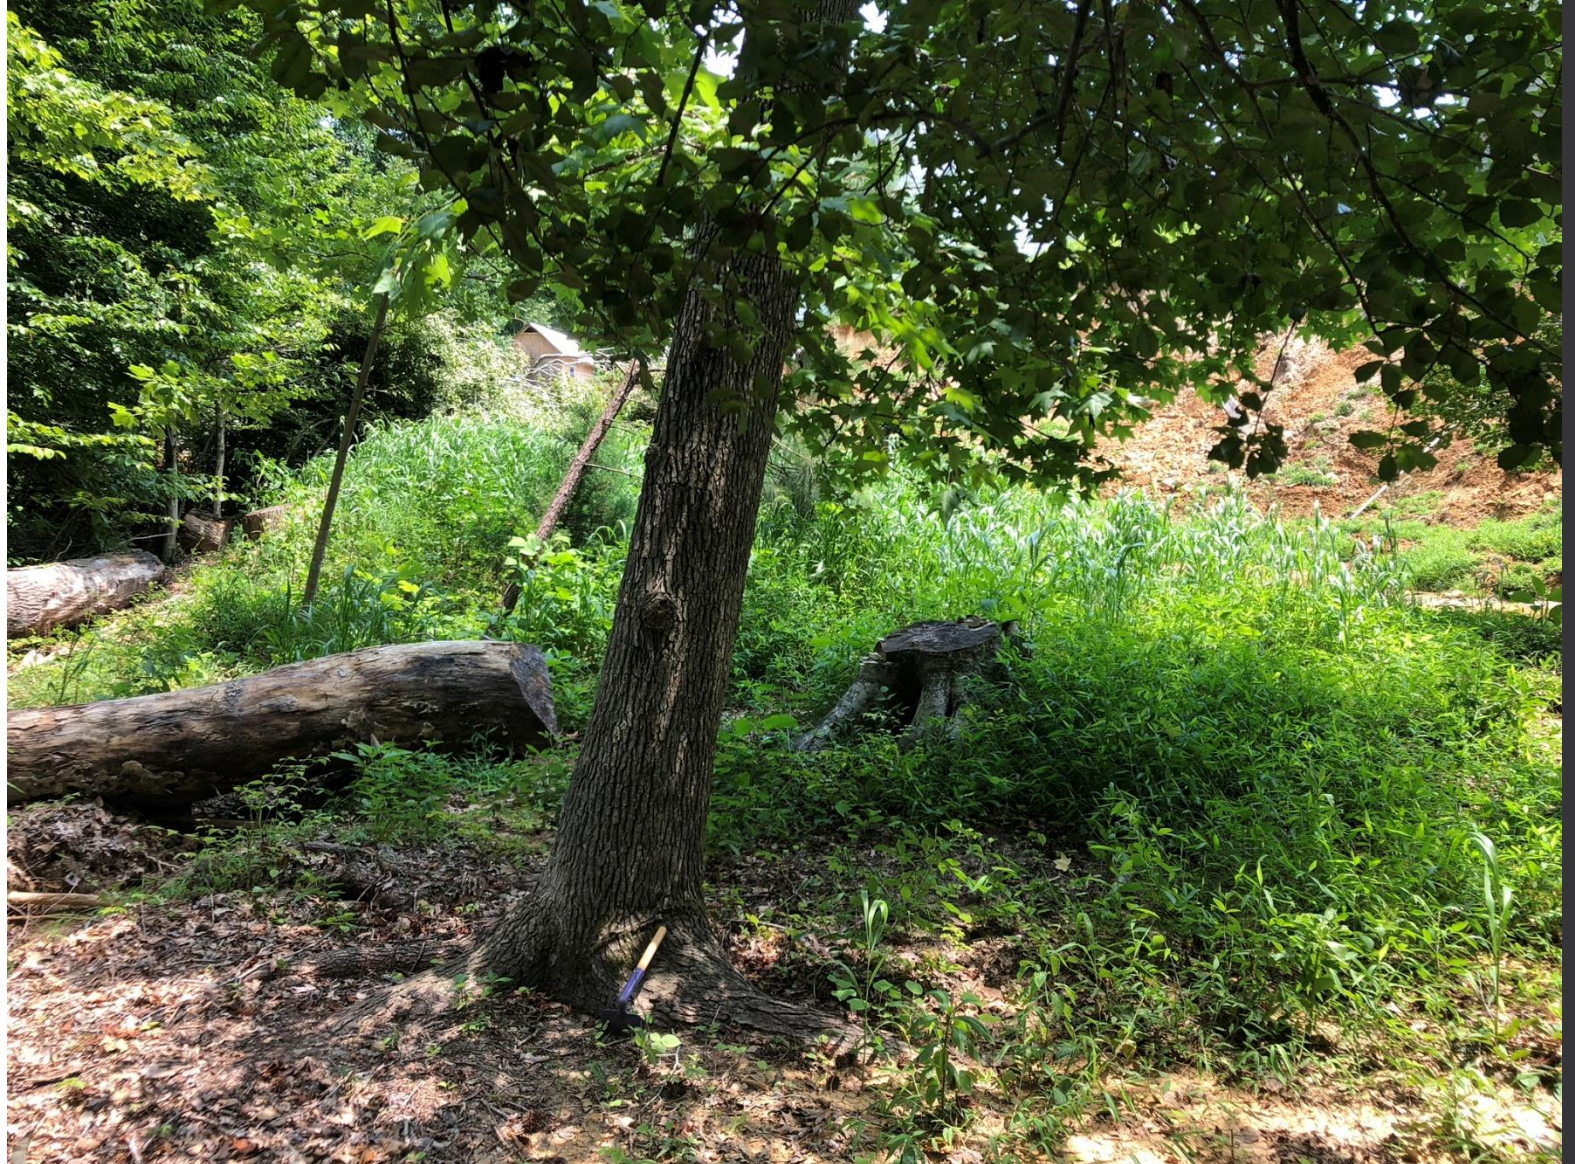
- DGMR revisited site on July 11
- Main headscarp approximately 20 feet high
- Ponding at base of headscarp
- Numerous back rotated trees indicating that there was a rotational component to the landslide movement

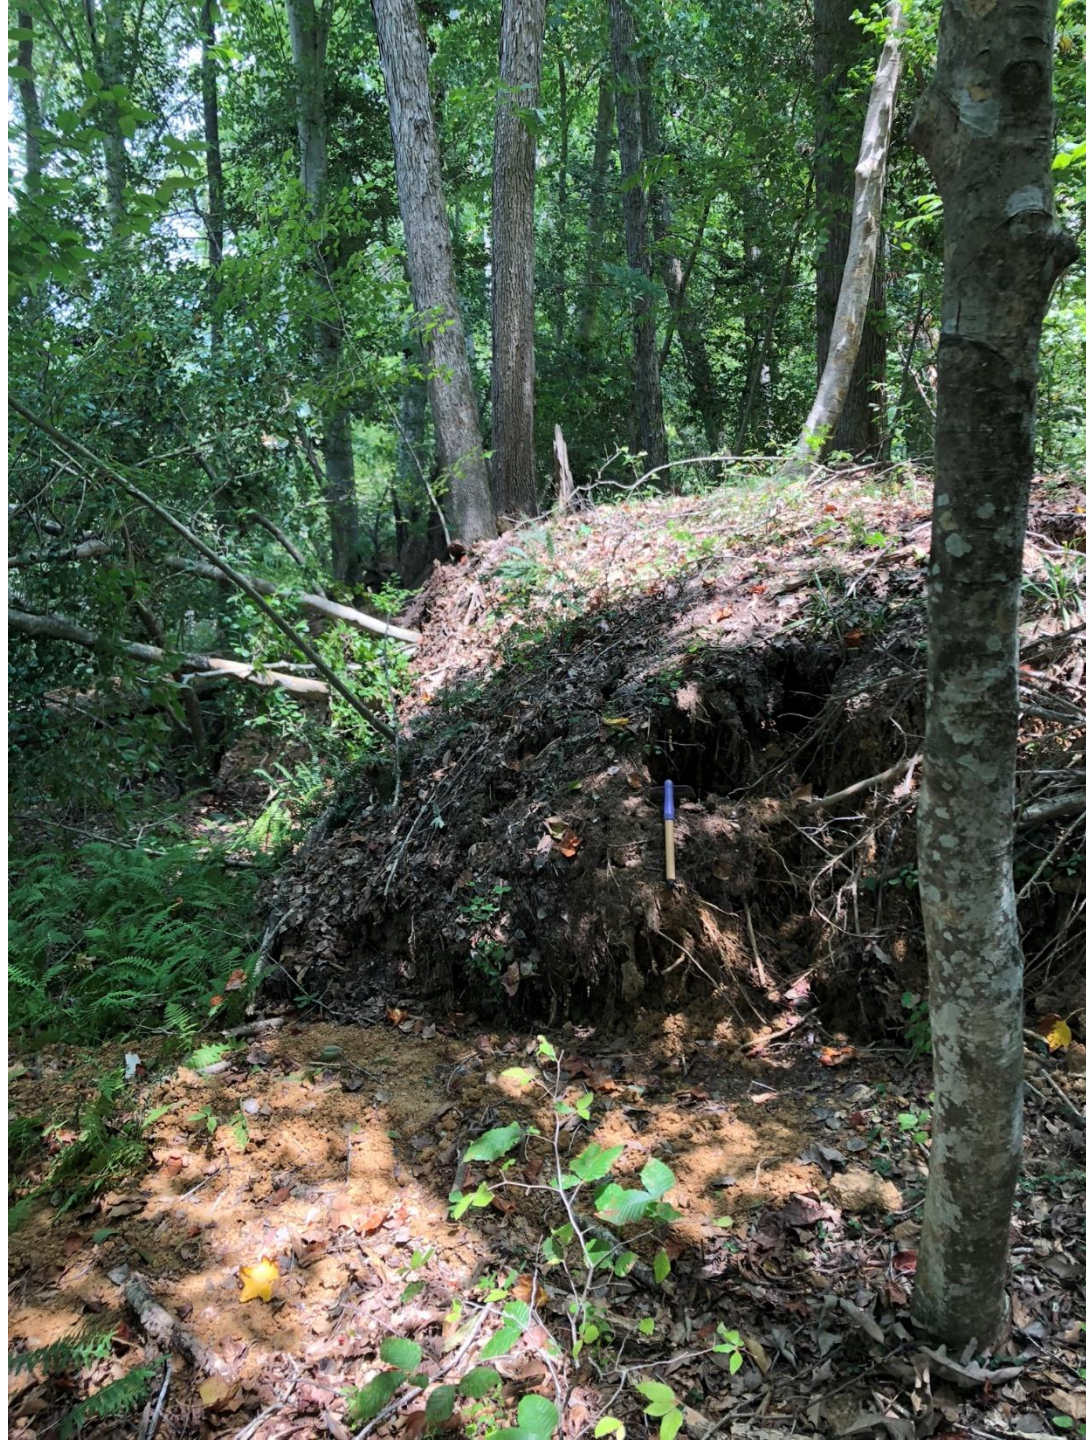
- 6ft high “roll-front” toe that had moved over the original ground surface

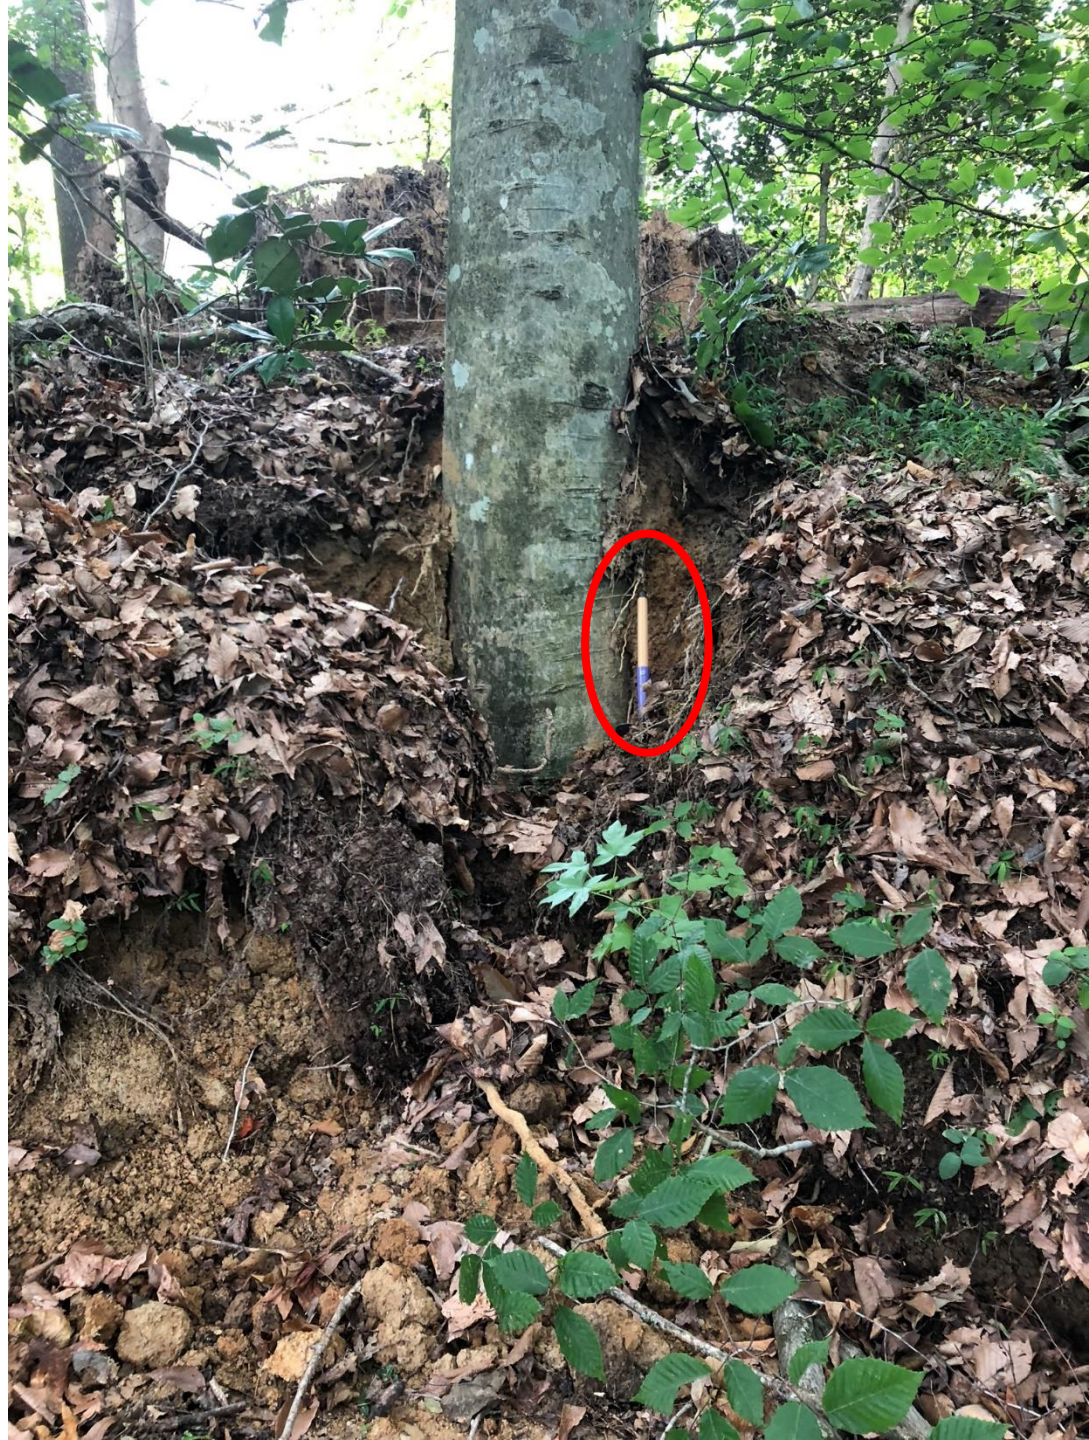
- 6ft high “roll-front” toe that had moved over the original ground surface
- Uprooted and buried trees in landslide debris

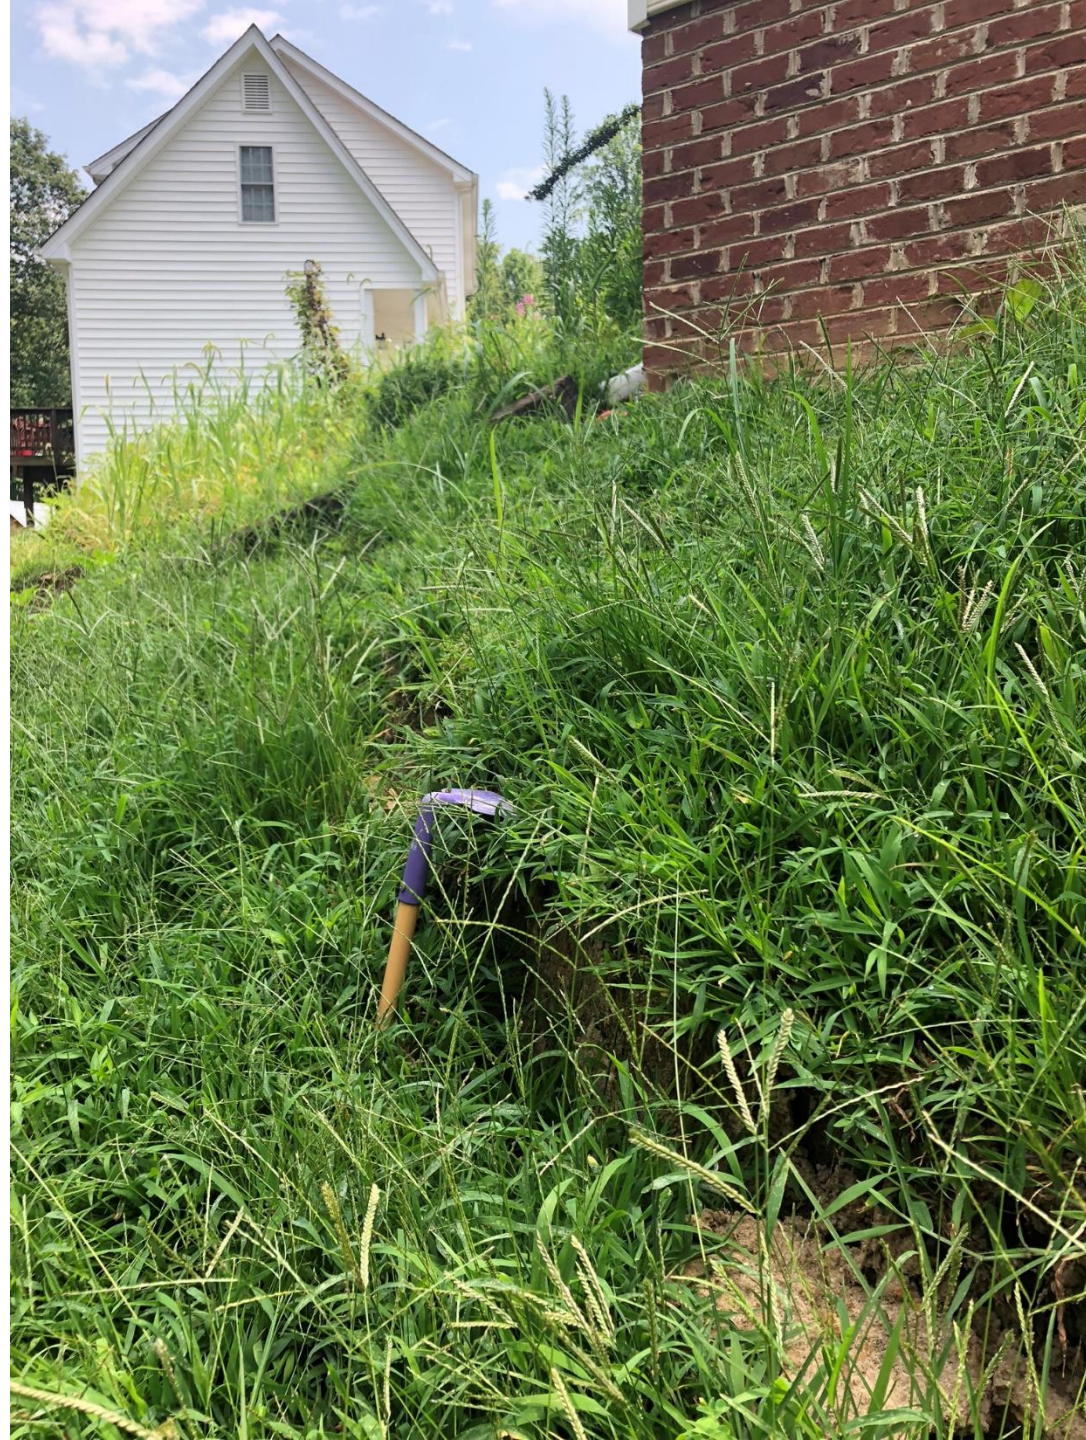
- 6ft high “roll-front” toe that had moved over the original ground surface
- Uprooted and buried trees in landslide debris
- Tension cracks with horizontal and vertical displacement indicated that the landslide was continuing to propagate uphill – dangerously close to 362 Nottoway

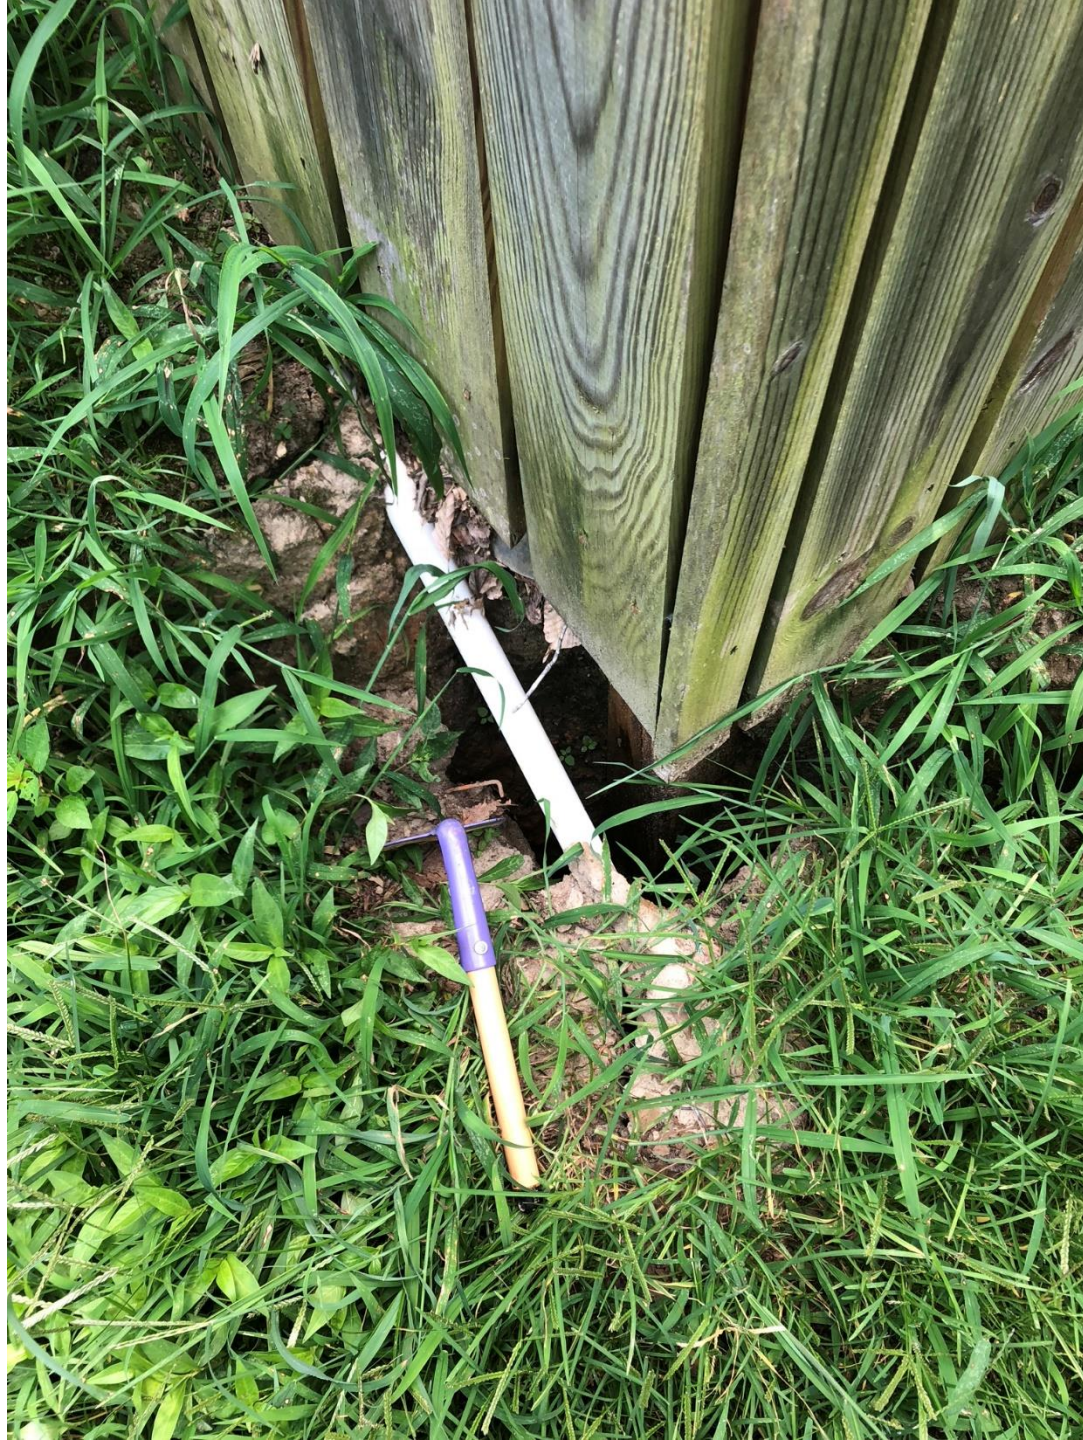
- 6ft high “roll-front” toe that had moved over the original ground surface
- Uprooted and buried trees in landslide debris
- Tension cracks with horizontal and vertical displacement indicated that the landslide was continuing to propagate uphill – dangerously close to 362 Nottoway

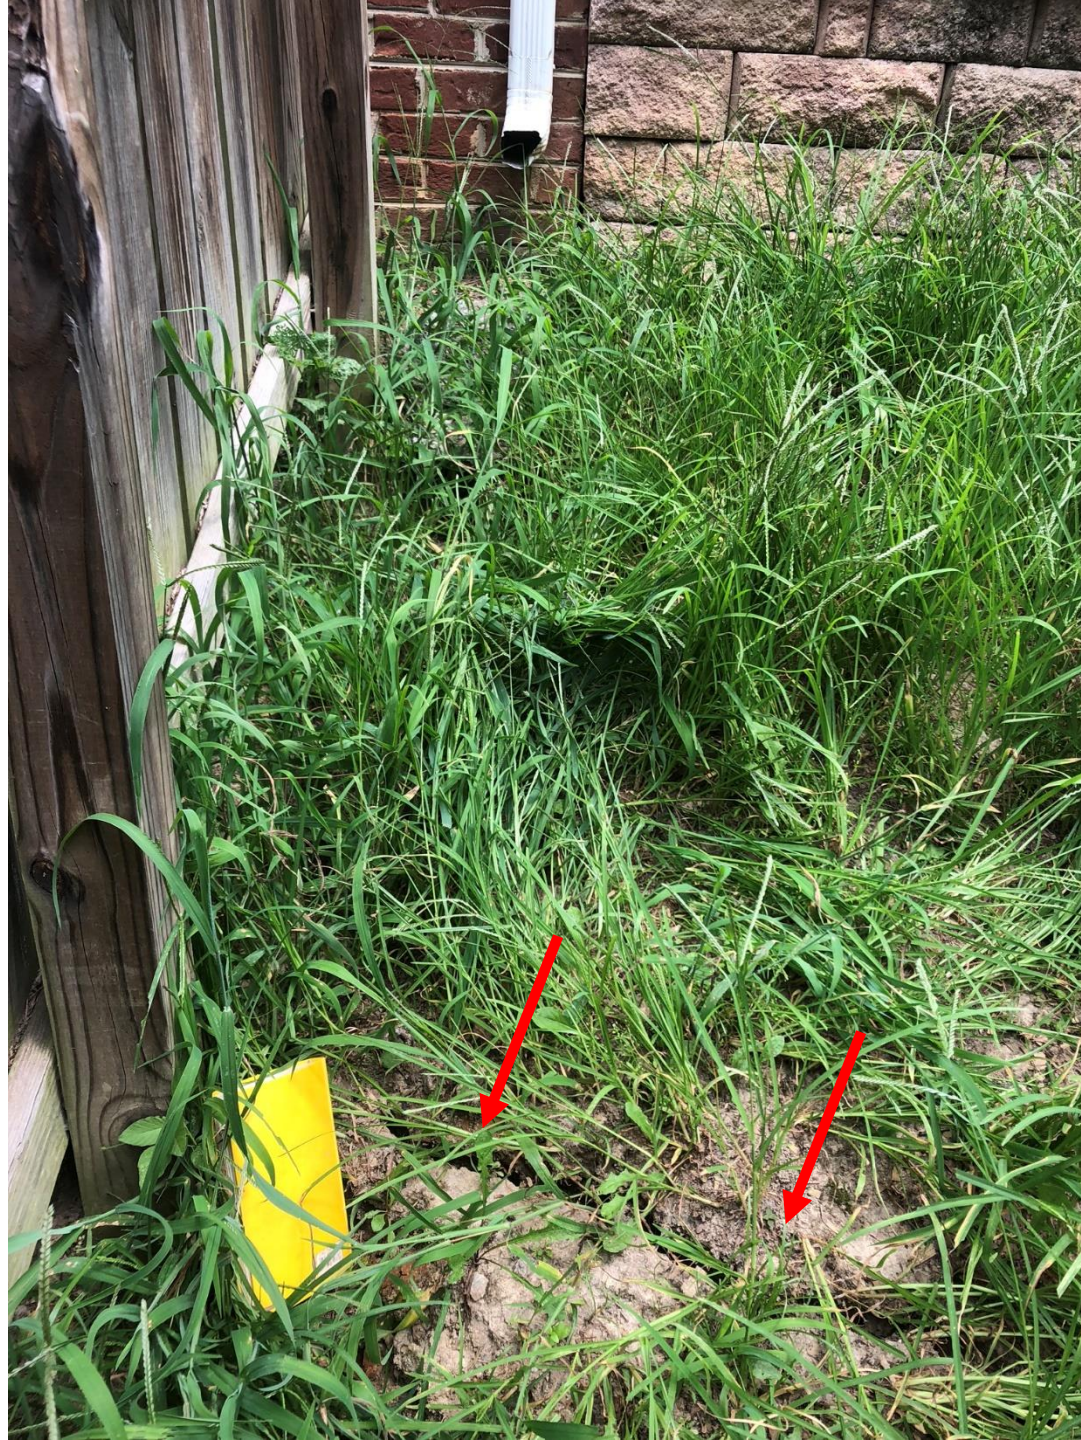
- 6ft high “roll-front” toe that had moved over the original ground surface
- Uprooted and buried trees in landslide debris
- Tension cracks with horizontal and vertical displacement indicated that the landslide was continuing to propagate uphill – dangerously close to 362 Nottoway

- Based on this evidence, the feature was identified as a rotational debris slide-flow based on Cruden and Varnes (1996) classification

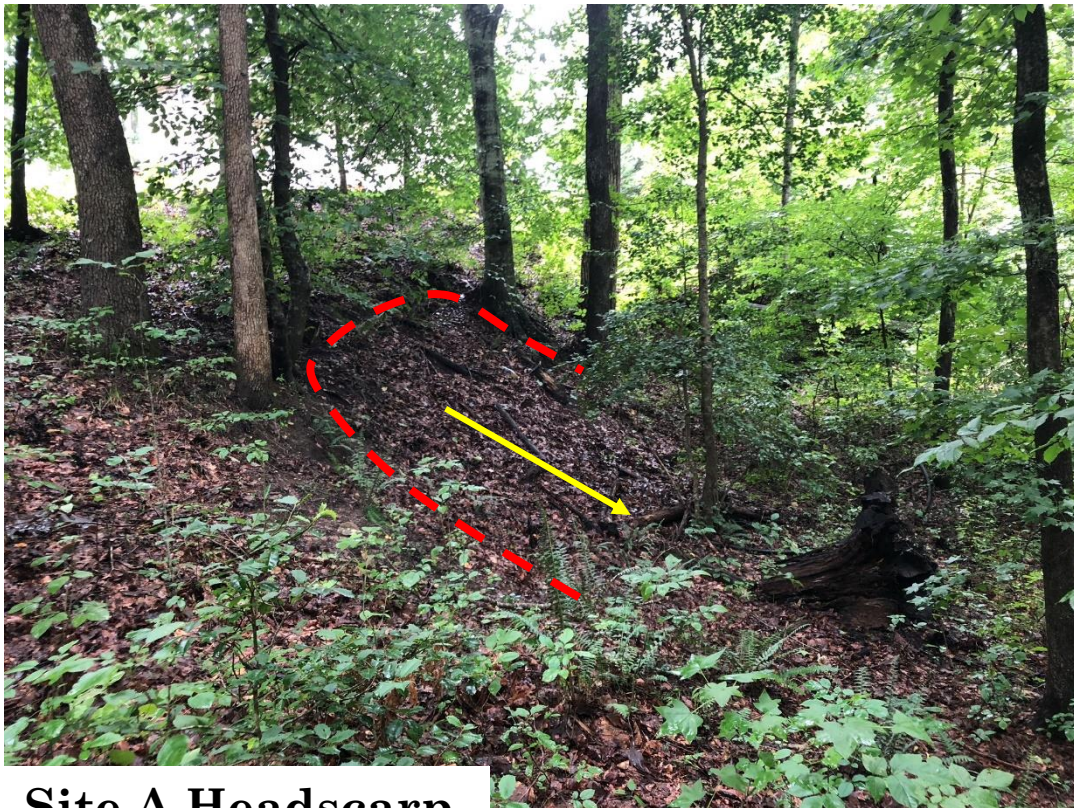
Site A Headscarp

- Revisited neighborhood July 25:
 - Site A = Debris flow
 - Site B = Debris slide
- Both had significant regrowth in the head scarps → landslides were older than 10 years
- Neither posed a threat to life or property

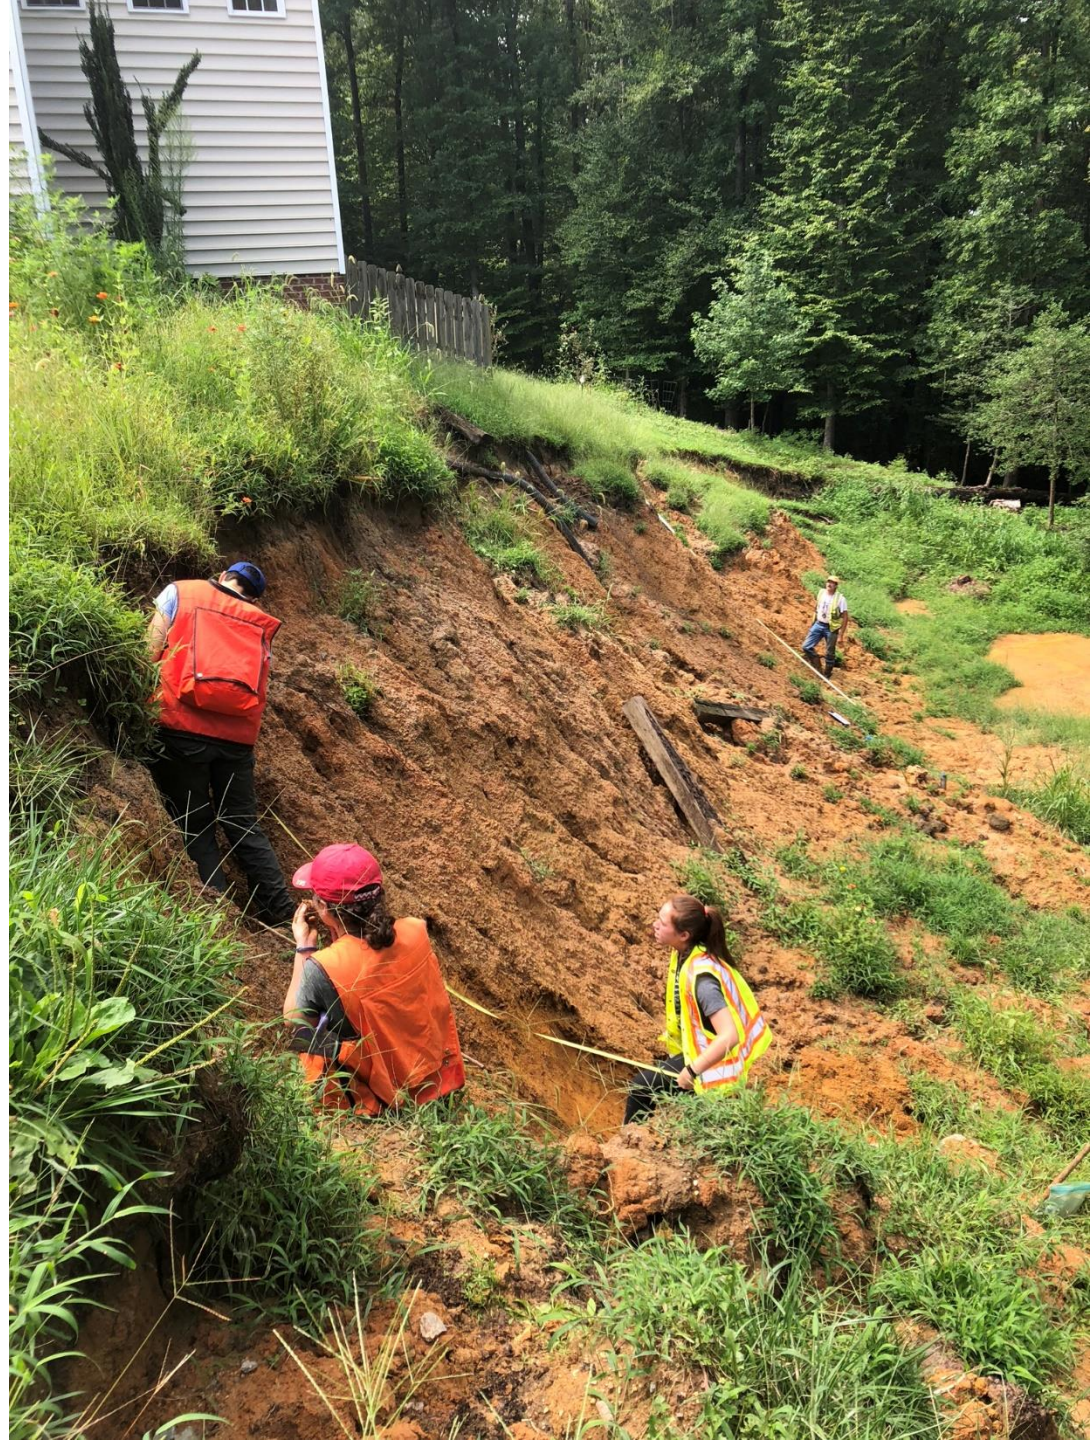
- Stratigraphy of the landslide headscarp examined by DGMR and USGS on August 1
 - Cold Harbor – 0-8.9 ft
 - Yorktown – 8.9-18 ft
 - Eastover – 18 to base of headscarp

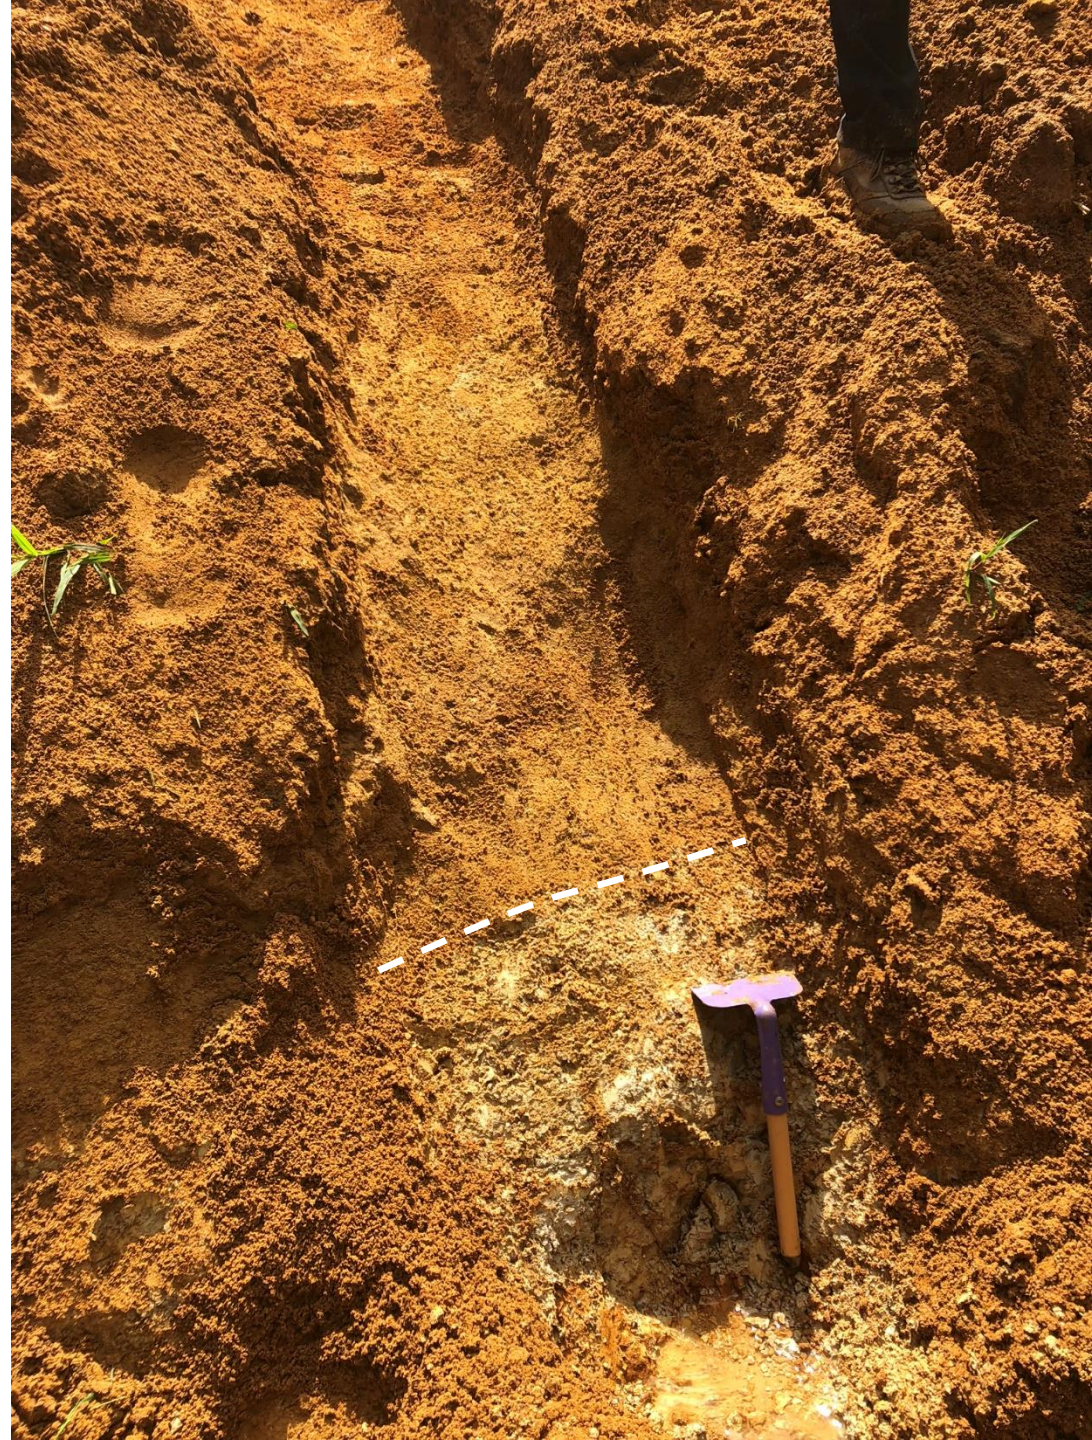
- Stratigraphy of the landslide headscarp examined by DGMR and USGS on August 1
 - Cold Harbor – 0-8.9 ft
 - Yorktown – 8.9-18 ft
 - Eastover – 18 to base of headscarp
- Eastover Formation – well-jointed, firm, silty clay that breaks easily along joint faces and fracture surfaces
 - Framboidal pyrite found on fresh surfaces
 - When exposing with hand shovel, groundwater readily flowed from fractures in the clay

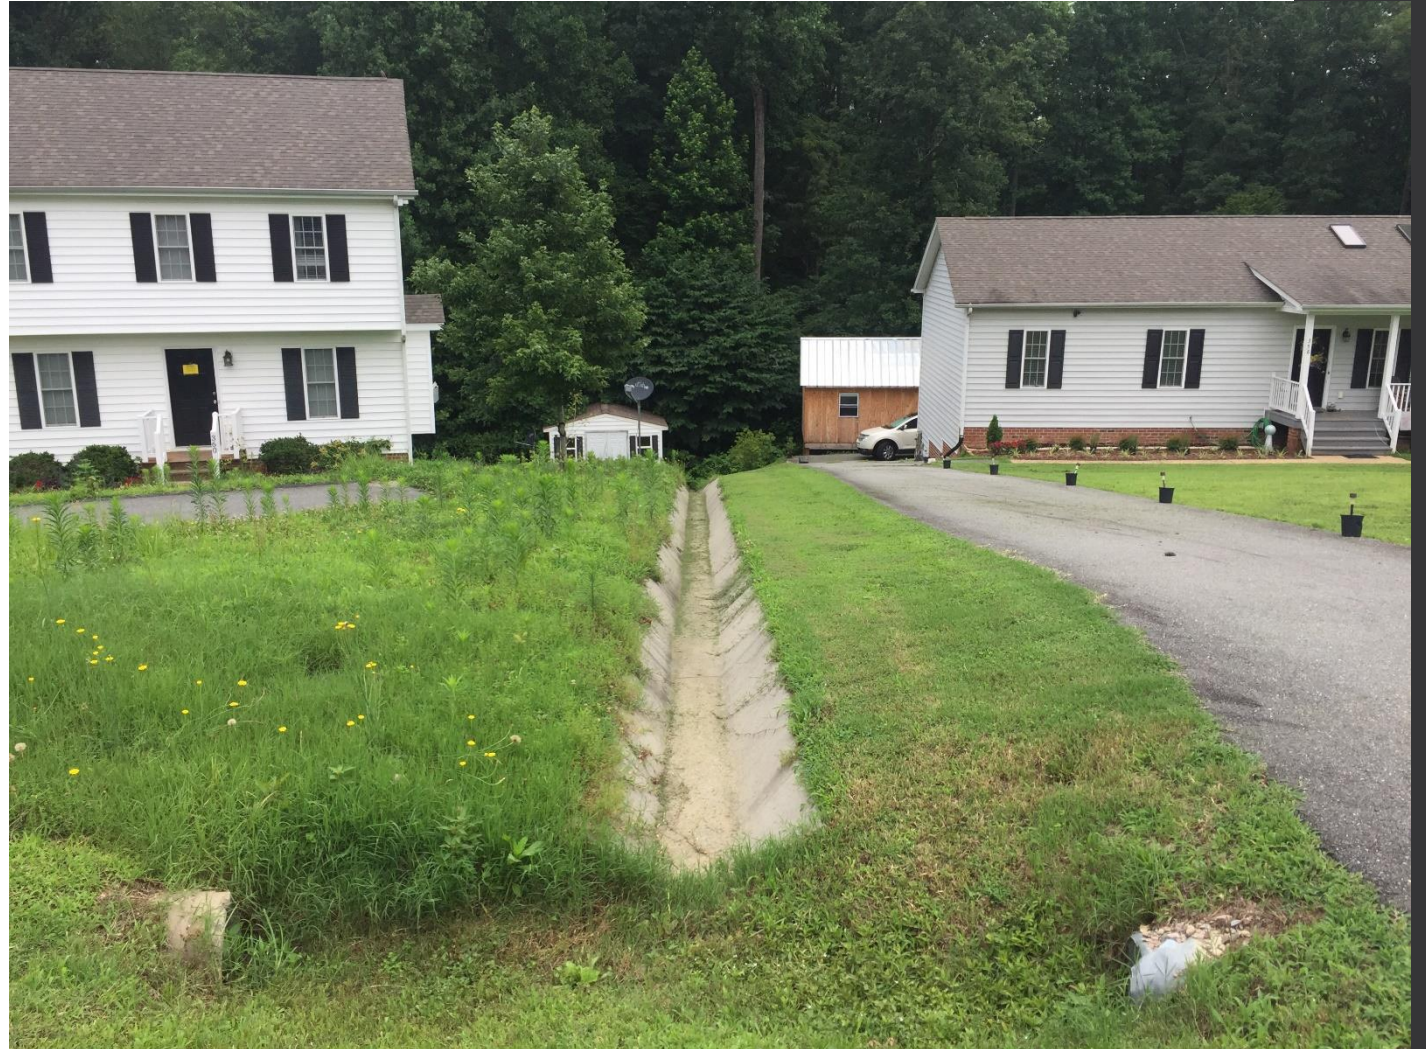
- Storm water runoff also contributed significantly to the slide and probably accelerated the reactivation of the slope
 - Concrete-lined storm drain between 358 and 360 Nottoway drains into the right-lateral flank of the landslide
 - Driveways between 360-362 Nottoway provided conduits for rainwater

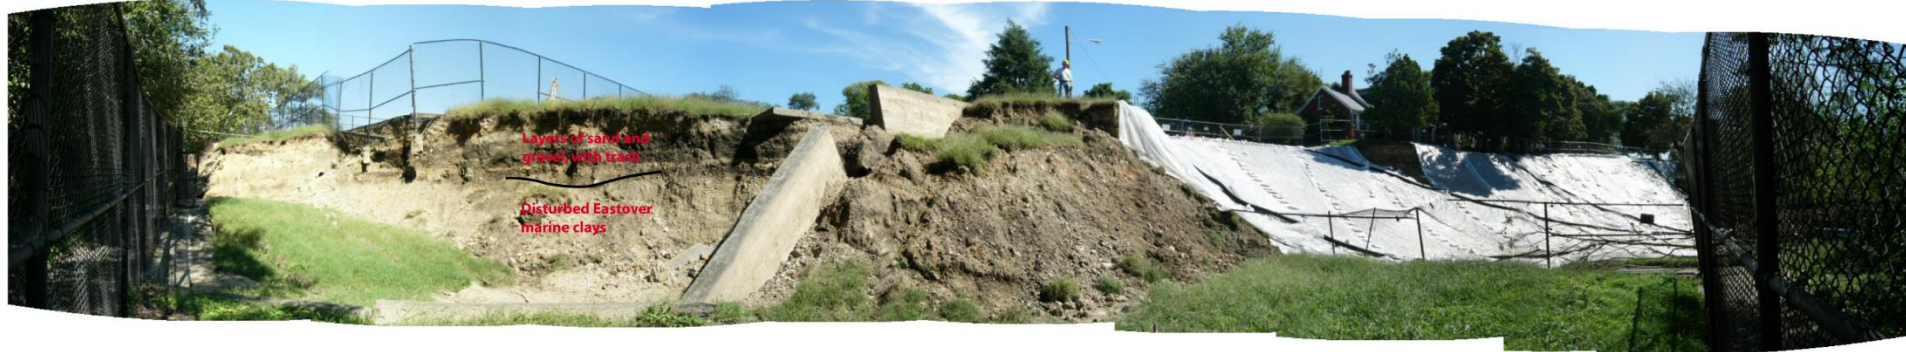
Figure 3: Panoramic photograph, panning from the north (left side) to east (right side) of the Chimborazo Park playground portion of the landslide, taken on September 21st, 2004. Photograph is from Location “C” in Figure 2. Notice the successive layers of fill in the main scarp on the left side of the photograph. “Natural ground” crops out along the scarp in the trees behind the fence on the far right side of the photograph. Also note the large tree behind the fence that leans back toward the main scarp, signaling that rotational slumping was a contributing mechanism for failure in this part of the landslide.
